Manhole Inspection Summary

Manhole # S23M1_012MH

Insp Date: **6/23/08 9:05 AM**

Location Address: **3311 Annapolis Rd.**

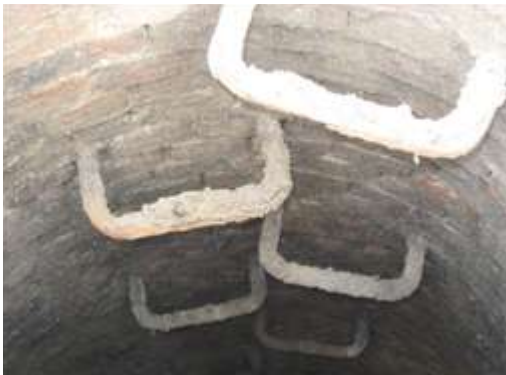
Steps Count: **7** Missing: **0** ☒ **Corroded**

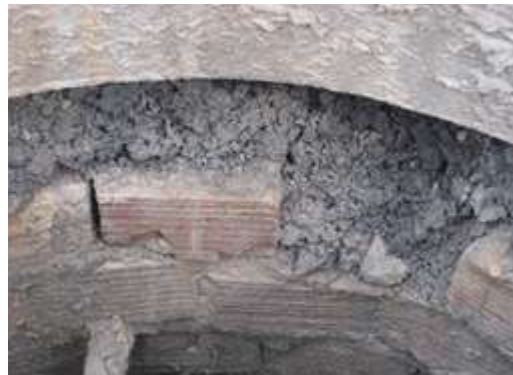
Defect 1

Condition: ☐ Sound ☐ Cracked ☐ Root Intrusion ☐ Loose Brick ☒ **Deteriorated**

Infiltration: ☐ None ☒ **Joint** ☐ Cracks ☐ Mortar ☐ Roots ☐ Wall

Frame-Chimney Joint.

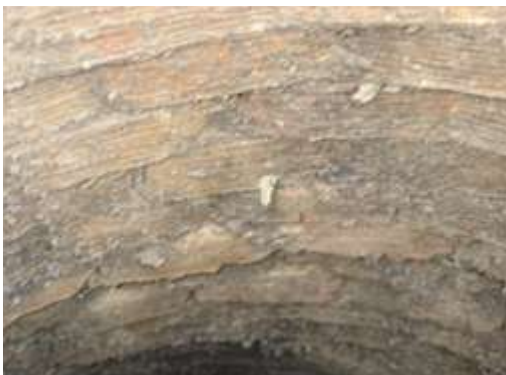
Defect 2

Infiltration: ☐ None ☐ Joint ☐ Cracks ☐ Mortar ☐ Roots ☒ **Wall**

Infiltration

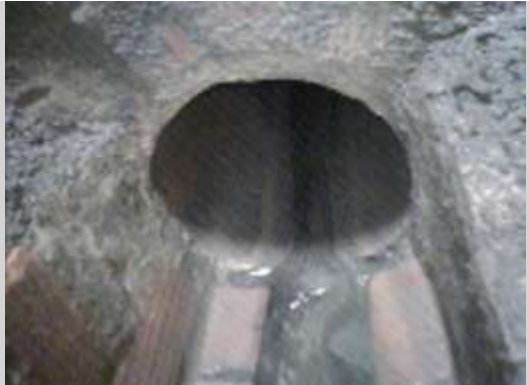
12 O'Clock Outflow

8 in. Circular Gravity Sewer
Pipe Out @ 12 O'Clock

Pipe Height: **8.4** (in.) Rod and Bar (Angled)
Pipe Material: **Clay** ☐ Pipe Lined
Invert Depth: **10.76** (ft.) Flow Characteristics: **Fast**
Deposits: ☒ None ☐ Mud ☐ Sludge ☐ Debris ☐ Grease
Silt Depth: (in.) Deposits Extent:
Infiltration: **None** Pipe Seal Cond: **Sound**

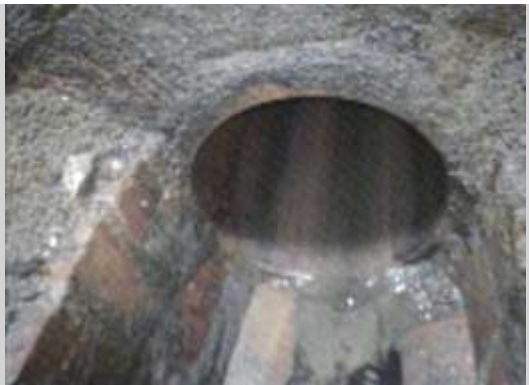
6 O'Clock Inflow

8 in. Circular Gravity Sewer
Pipe In @ 6 O'Clock

Pipe Height: **8.4** (in.) Rod and Bar (Angled)
Pipe Material: **Clay** ☐ Pipe Lined
Invert Depth: **10.70** (ft.) Flow Characteristics: **Fast**
Deposits: ☒ None ☐ Mud ☐ Sludge ☐ Debris ☐ Grease
Silt Depth: (in.) Deposits Extent:
Infiltration: **None** Pipe Seal Cond: **Sound**
